Trauma surgery at the AMC in Amsterdam

Philips BV Pulsera with 3D imaging

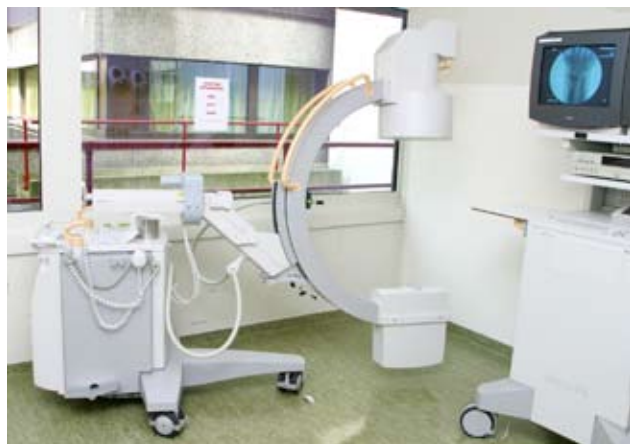
The BV Pulsera

For more than a year Dr. Haverlag has been using a BV Pulsera with 3D-RX. This is a mobile surgical C-arm system, with provision for intra-operative three-dimensional imaging. This enables any problems with fracture repair or fixation material (especially for the extremities) to be detected during the operation, so that any action needed to ensure a satisfactory result can be taken immediately.

The 3D images are acquired using the “propeller” movement of the BV Pulsera. This gives a high degree of mechanical stability, so that the image reconstruction is unaffected by mechanical vibration. Dr. Haverlag: “In my opinion the 3D images obtained using the BV Pulsera with 3D-RX have better resolution and contrast than those of comparable systems, and are relatively insensitive to metal artifacts.”

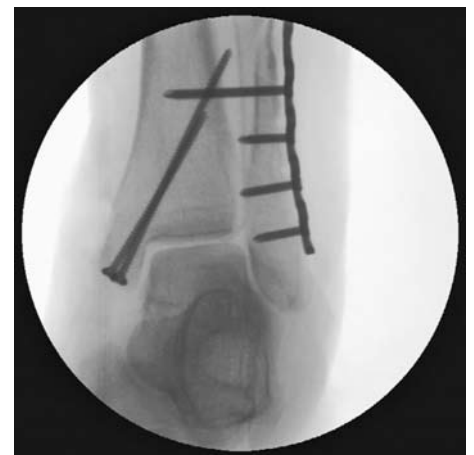
2D fluoroscopy image, showing that repositioning seems satisfactory

The BV Pulsera with 3D-RX has been used in 32 trauma operations to date, including surgical correction of extensive intra-articular fractures of the wrist and ankle. The following clinical example clearly shows the added value of intraoperative 3D imaging. This patient had a luxation fracture of the ankle. After fixation a fluoroscopic 2D image was made and, on the basis of this image, it was decided that the repositioning was satisfactory. However, a 3D

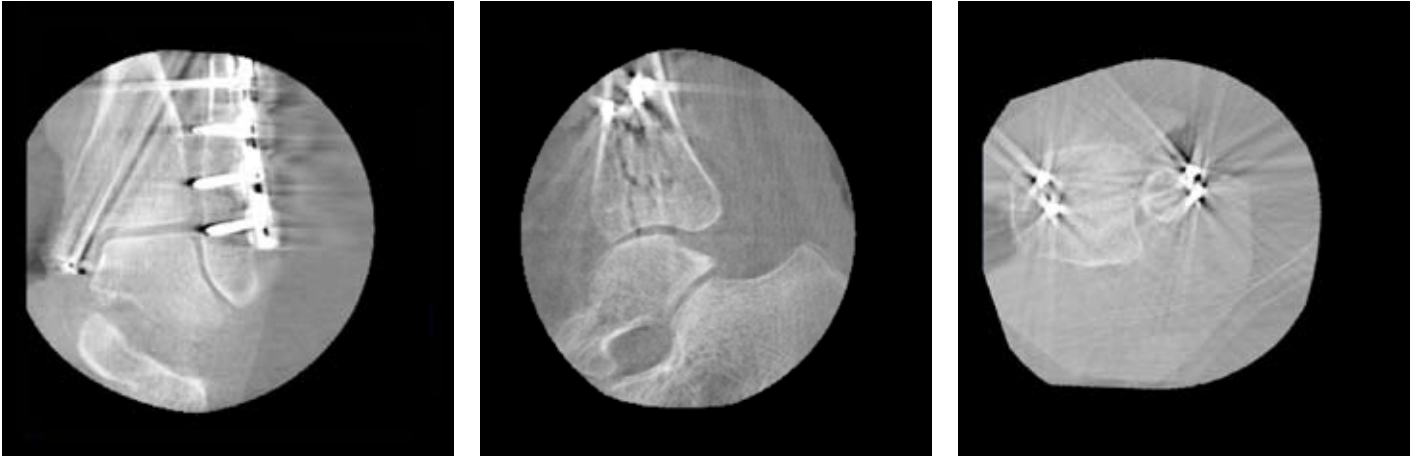
3D fluoroscopy image: coronal, sagittal and axial views, showing that the repositioning is not satisfactory. The connection between the fibula and the tibia is too tight, with marked rotation of the talus.

scan was also made. This showed that there was a discongruence in the talocrural joint: the connection between the fibula and the tibia was too tight, with marked rotation of the talus. Because of these findings immediate revision was performed. The 3D scan made after that showed that the syndesmosis between the tibia and fibula was now correctly positioned, and that the rotation of the talus axis had been corrected.

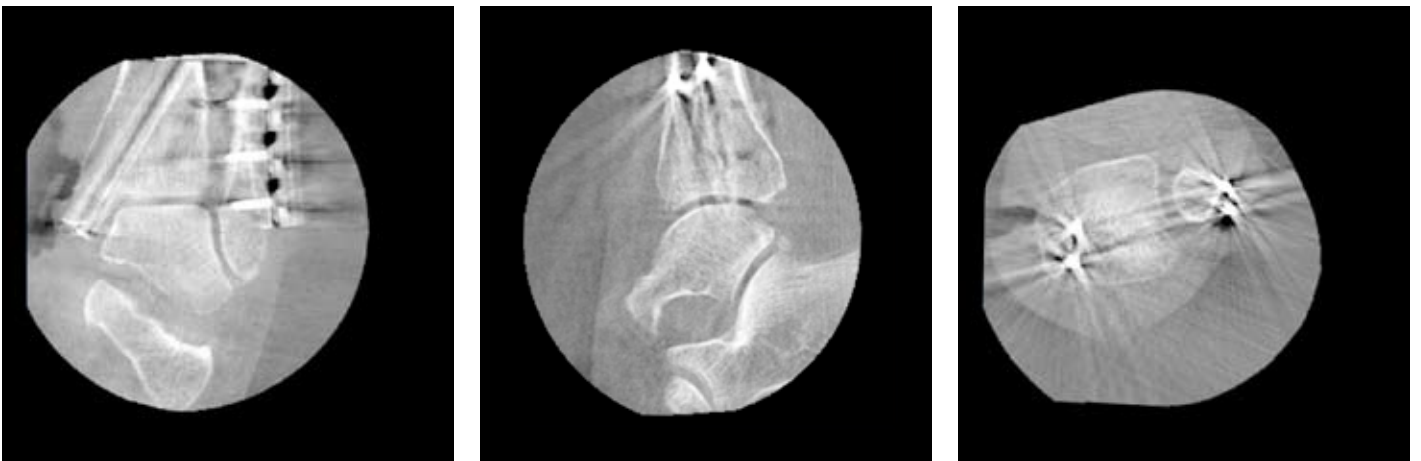
3D fluoroscopy image after the immediate revision: coronal, sagittal and axial views. The syndesmosis between the tibia and fibula is now correctly positioned, and the rotation of the talus axis has been corrected.

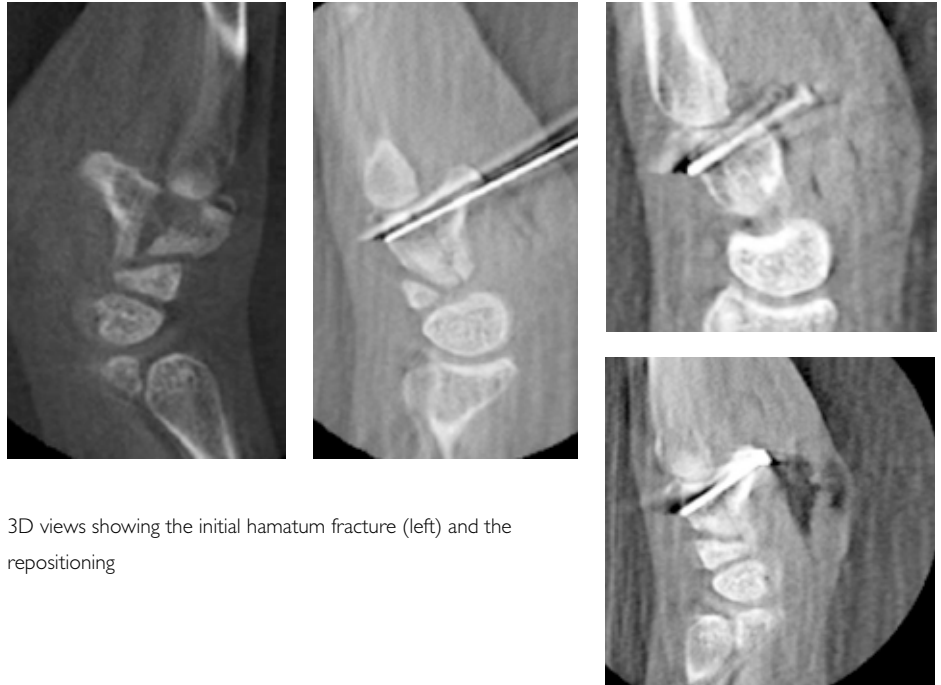
3D views showing the initial hamatum fracture (left) and the repositioning

The second clinical example is the fixation of a fracture of the hamatum. This is relatively easily achieved with the help of intra-operative 3D.
